2022 SILER – repair exhaust muffler

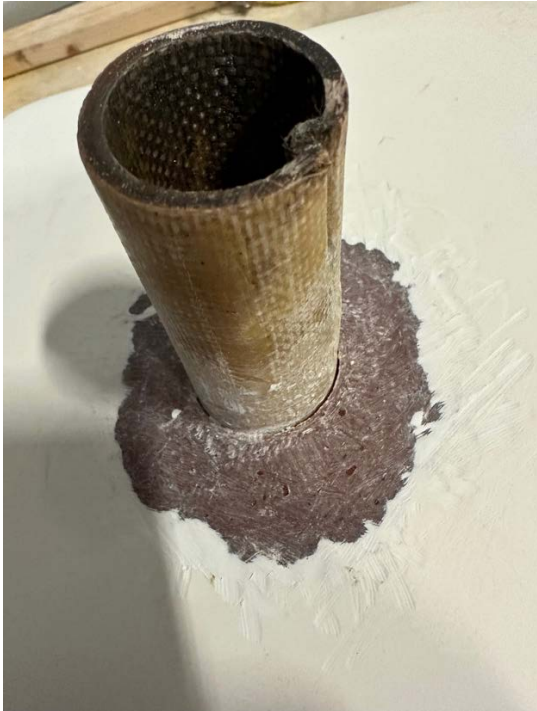
After proper cleaning inlet of the muffler a visible bad connection to the housing and crack in the pipe itself.

Inlet pipe repaired with additional layer of GRP.

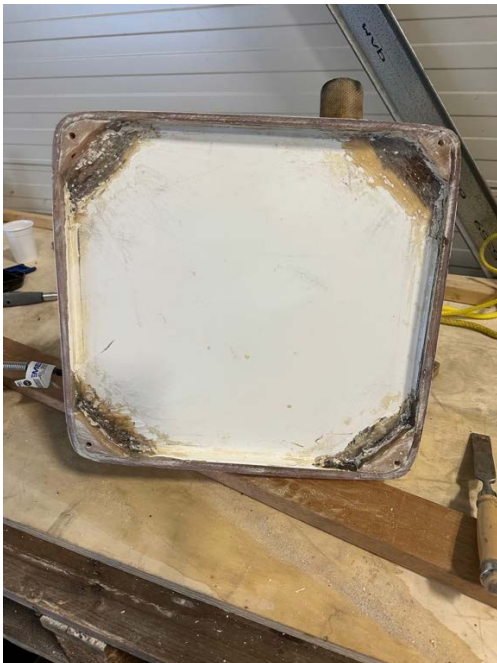
At the bottom bad connections and signs of earlier repairs by previous owner.

Bottom part fully filled with epoxy till flush.
