Follow-up to the split at the top rudder bearing structure of our 2002 Catalina 36. Via email I was able to communicate with Catalina Yachts. Both Warren and Gerry responded that the best method to correct the split was to glue it back together. They recommended a product call Plexus for the bonding. The following is the reply from Warren and Gerry:

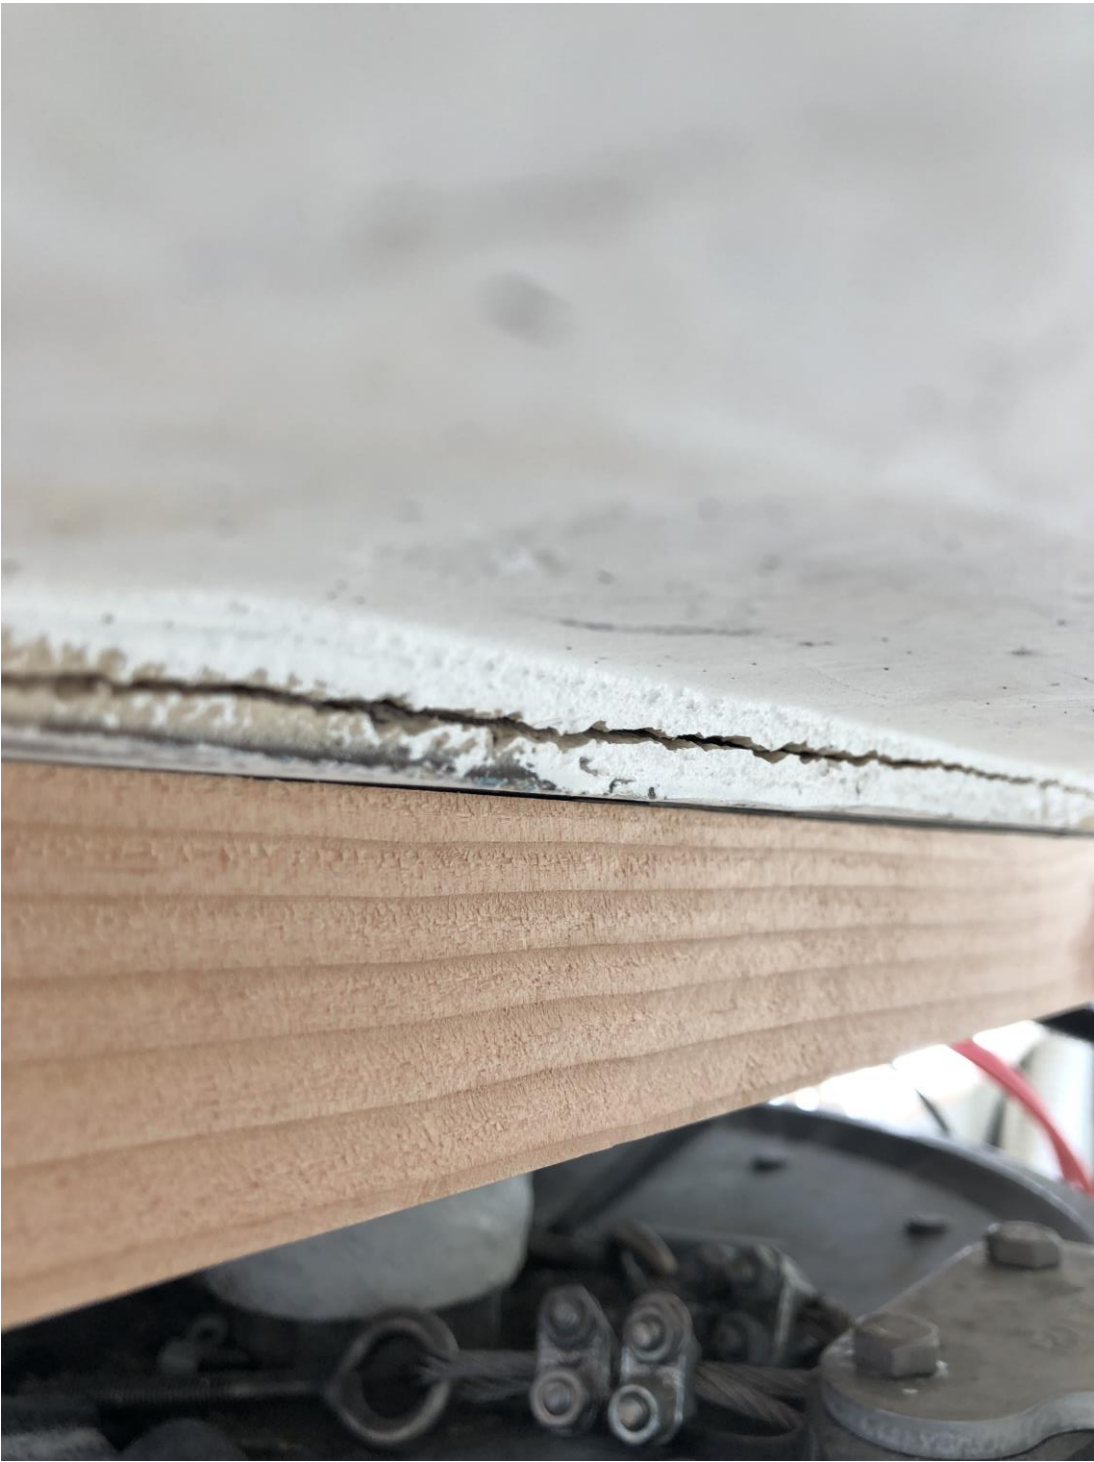
Caul in place for dry run.

I set up the clamps and caul and did a dry run. The dry run allowed me to evaluate clamping pressure and I could see if the cracks were adequately closed and alignment was good once clamped. The dry run also gave me an opportunity to mark locations and see how long it would take to get the clamps set once the epoxy was in place. All was good, so I started to inject the epoxy. I had a helper fill resin syringes directly from the self-mixing tube of 6-10 epoxy while I (5'7" 165lbs) worked from within the lazerette. The narrow tip of the syringe allowed me to get the epoxy deep into the cracked area. The injection process took about 20 minutes. I used a full tube, 6.4 oz., of the 6-10 epoxy.

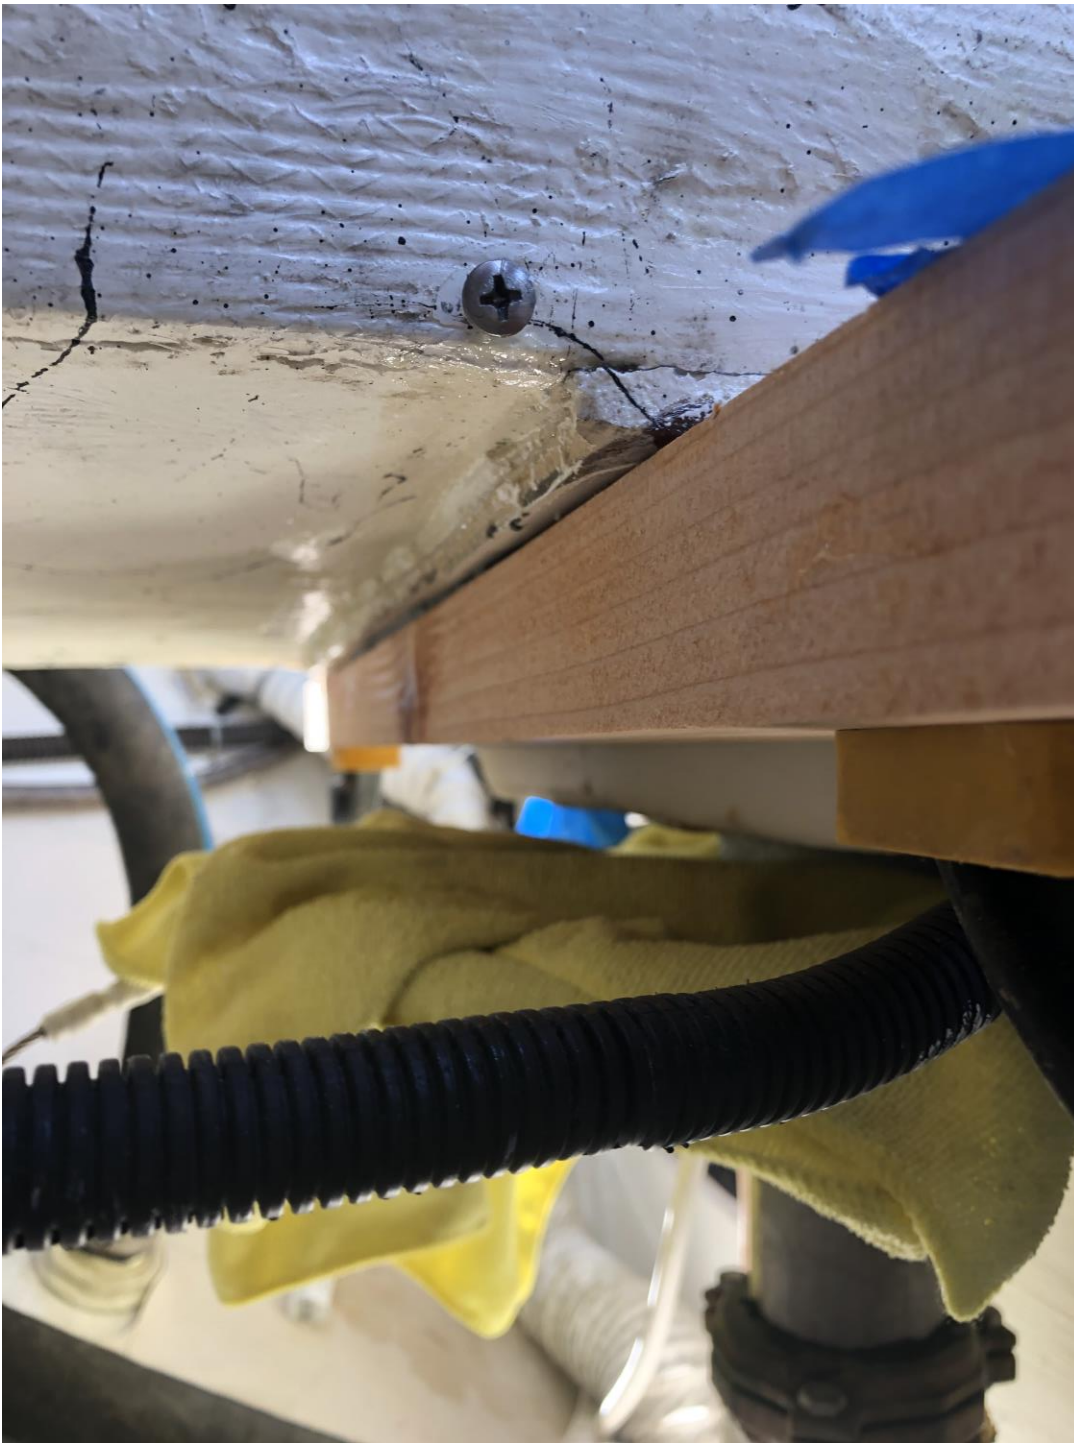
Caul in place after epoxy injected (view from starboard lazarette). Note rags on radial to catch run out of epoxy. Runout has been clean up at this point, Gorilla tape on caul for release in case it ended up glued to the fiberglass.

Once the epoxy was injected I put the caul in place and use the clamps to pull it up against the loose panel. I used a two by across the top of the lazerette openings to help spread the load across the gel coat edges, wanting to avoid damaging the opening. Wax paper or tape should be applied to the caul to avoid having it get glued to the fiberglass. I used rags to protect the radial drive from epoxy ooze during the clamping process. Time from initial injection of epoxy to wiping the last run out was 35 minutes. The open time on the 6-10 epoxy is 40 minutes.

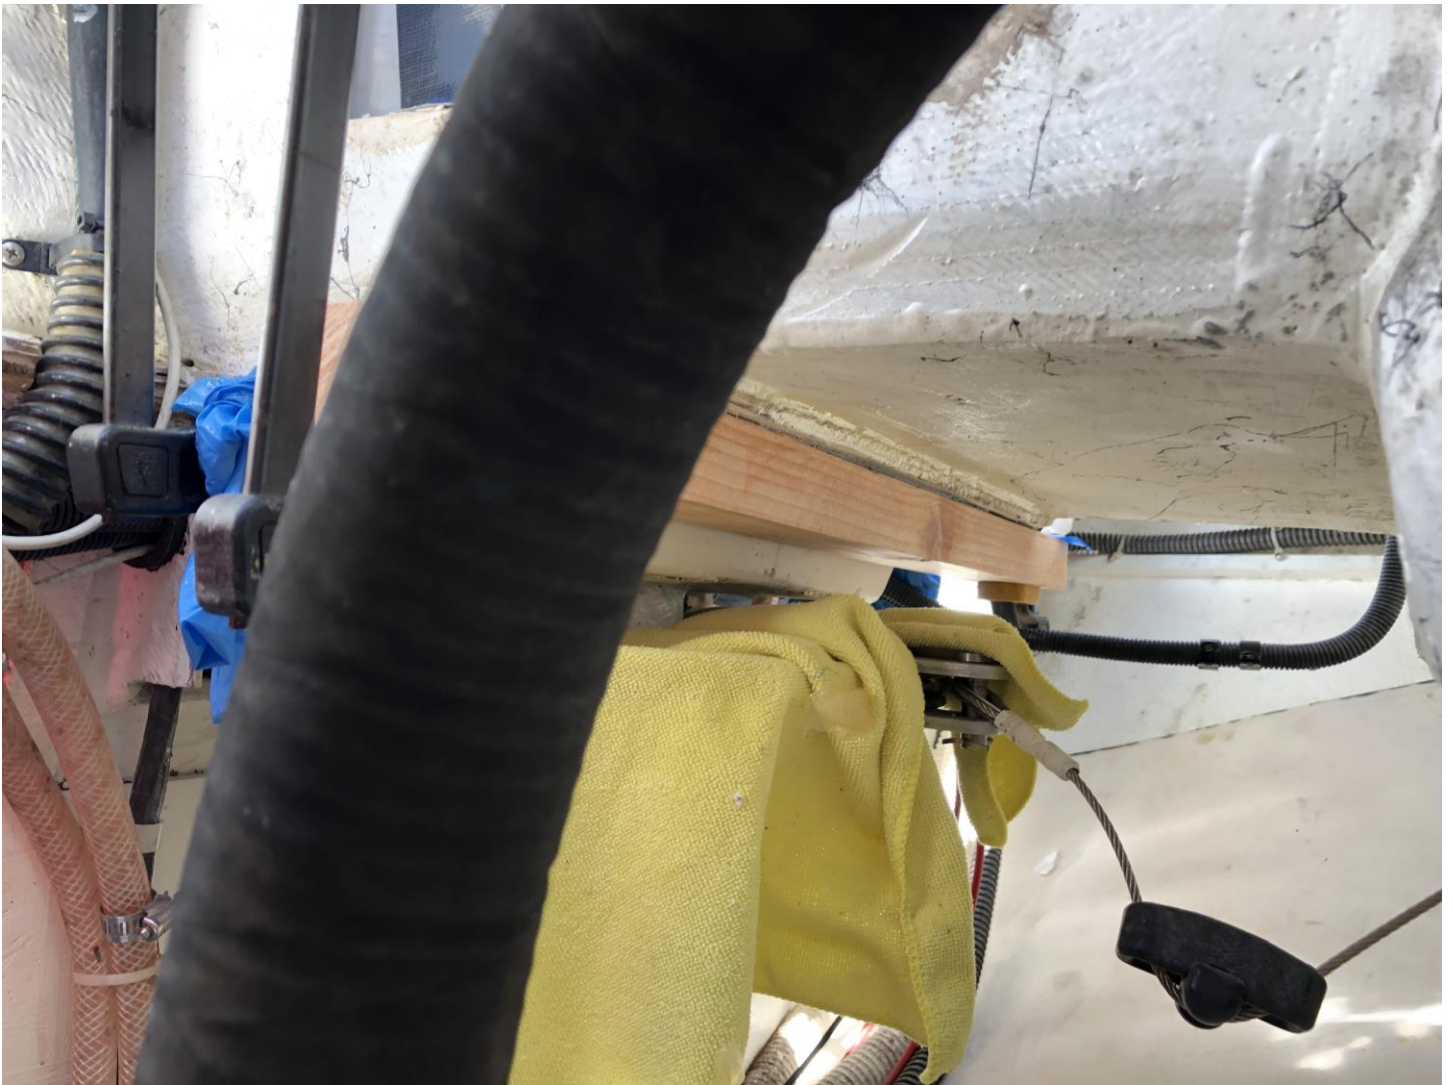
View from Port side lazarette.

Rubber gloves on clamps to prevent adhesion to fiberglass from runout.

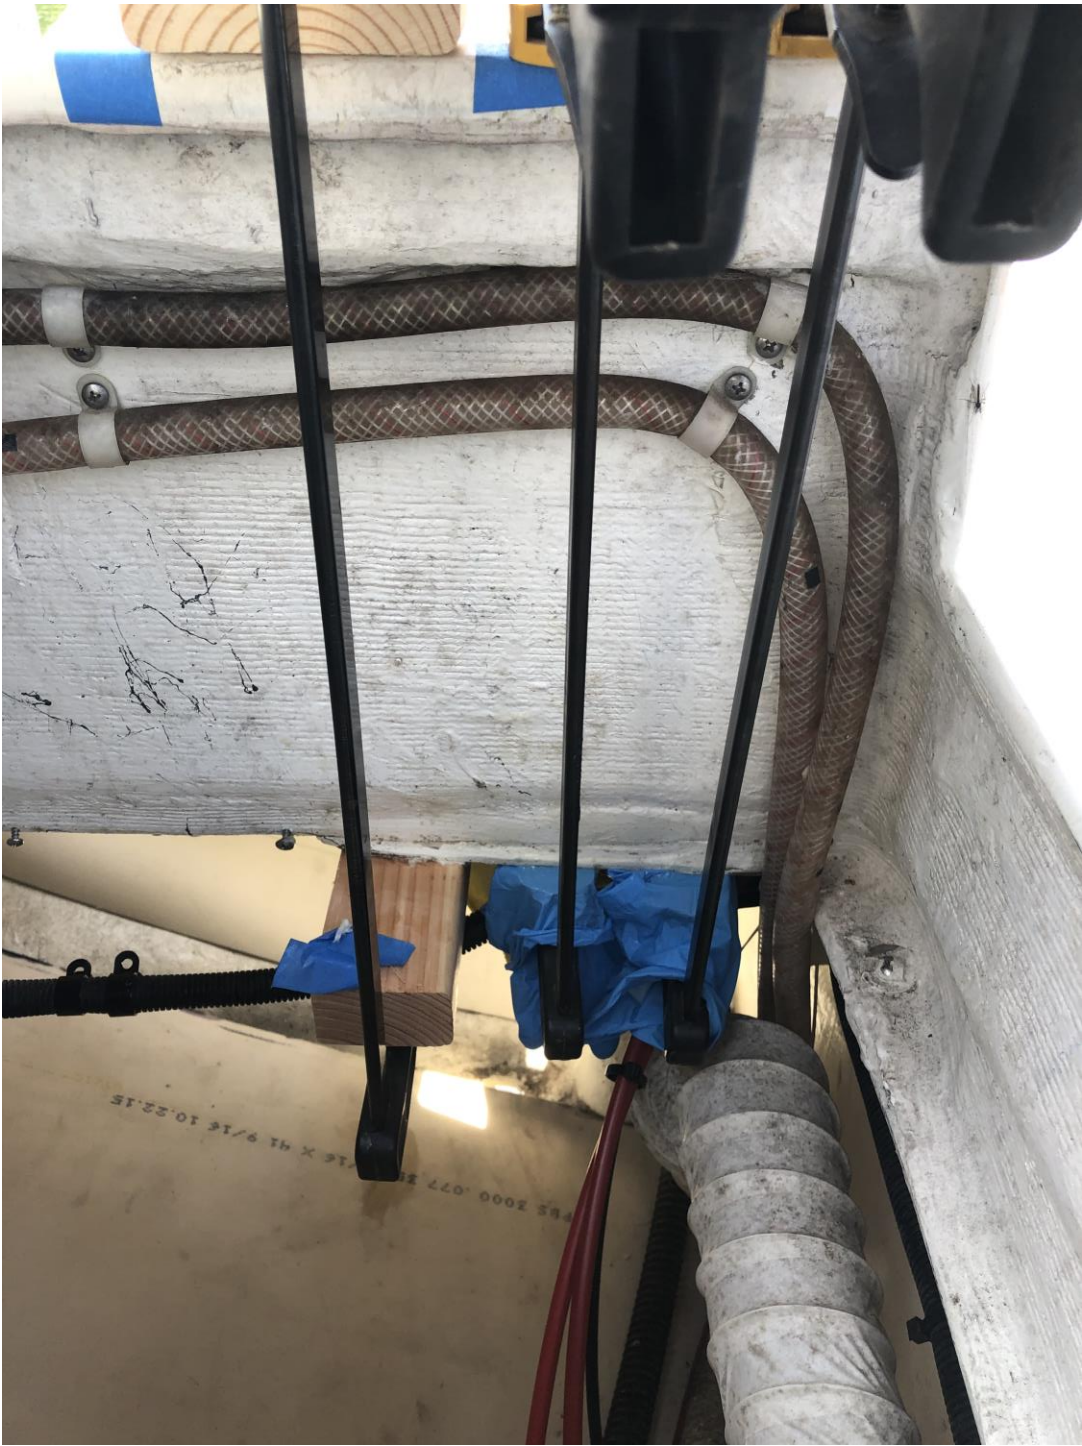
Clamps viewed from starboard lazerette.

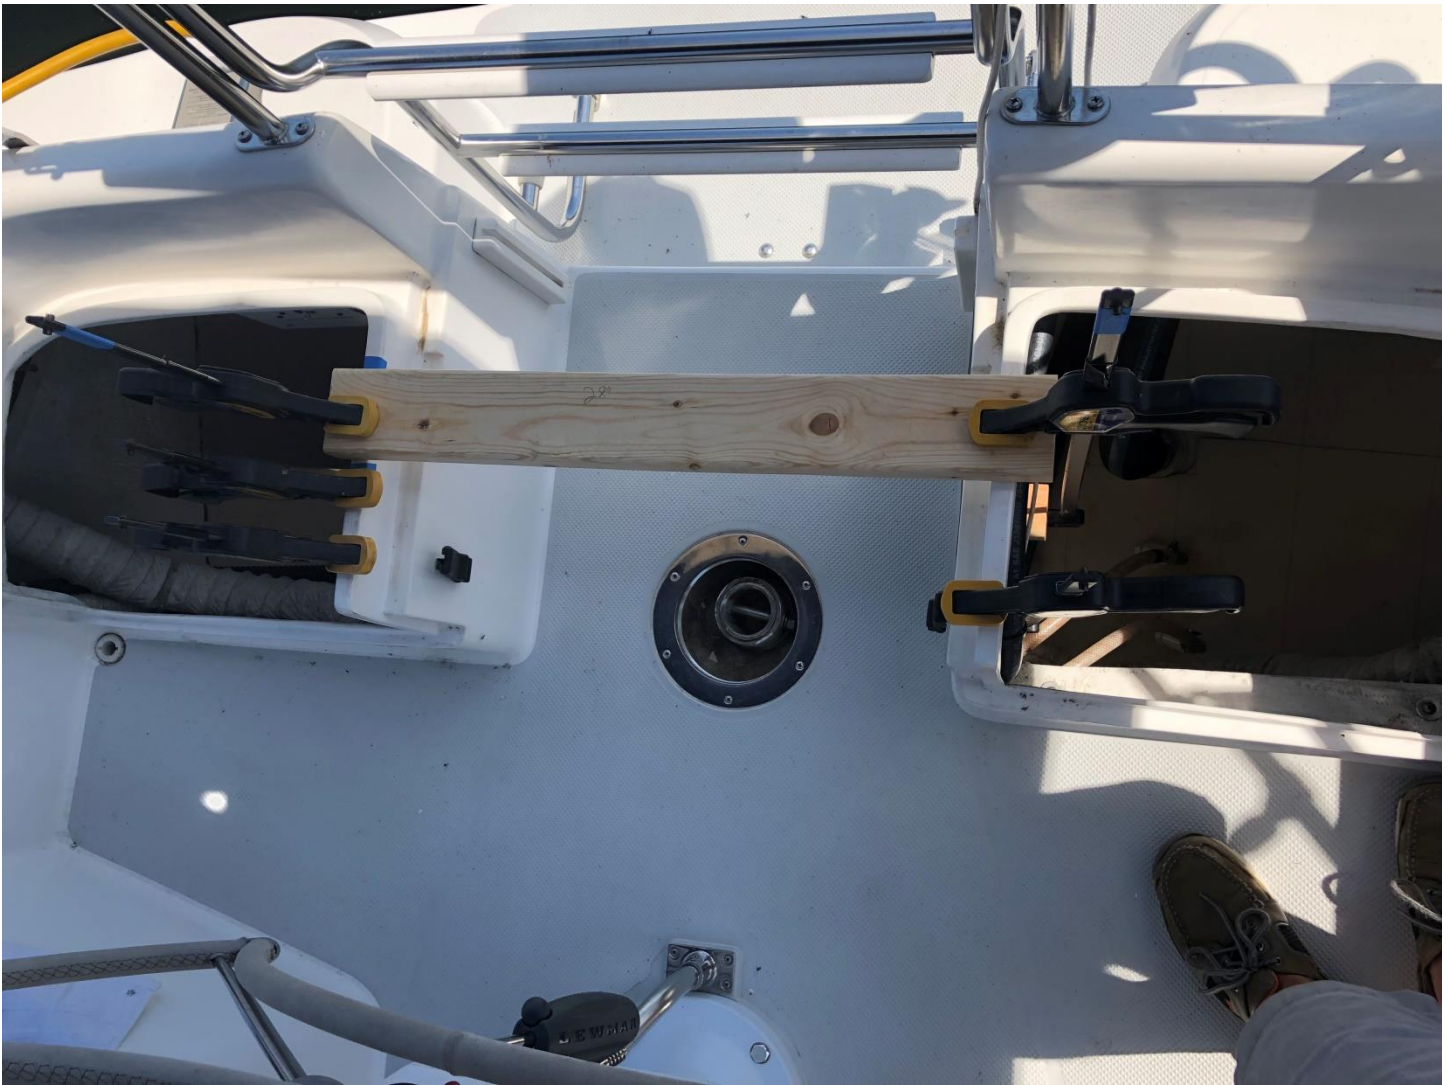
Clamps view from above.

You can see emergency rudder opening, some epoxy run out, mostly from the stern side, occurred into this area, but did not pose any issues or come near the bearing area.

3rd clamp on port side would not stay seated due to odd angle, slipped off. In the end it was not necessary.

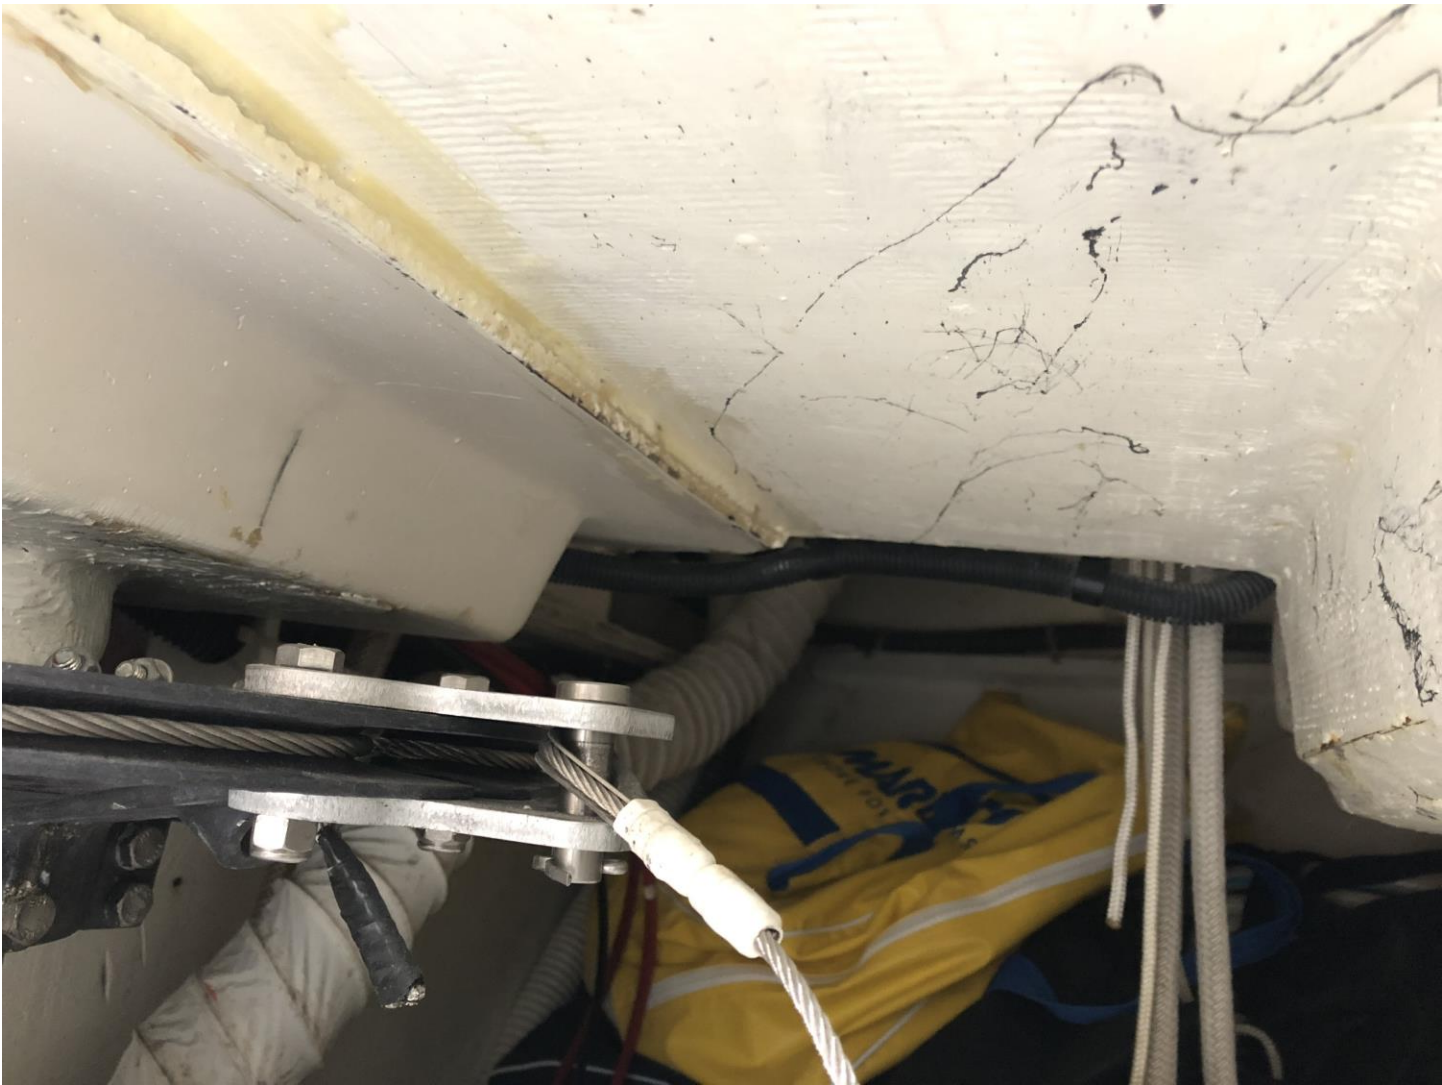
Cured joint.

Cure time for the epoxy is 5-7 hours depending on temps. I let it sit overnight, a total of 18 hours from start. I removed clamps and inspected, all looked good. Sailed for 5 hours that day in 5-10 knots of wind. Checked the area after returning to the dock and all was still looking good.
