Hello Catalina skippers! I am seeking advice on repairing bilge stringer water damage.

boat is a 2002 Catalina 36, shoal draft, in mast furling, M35B, Lake Michigan

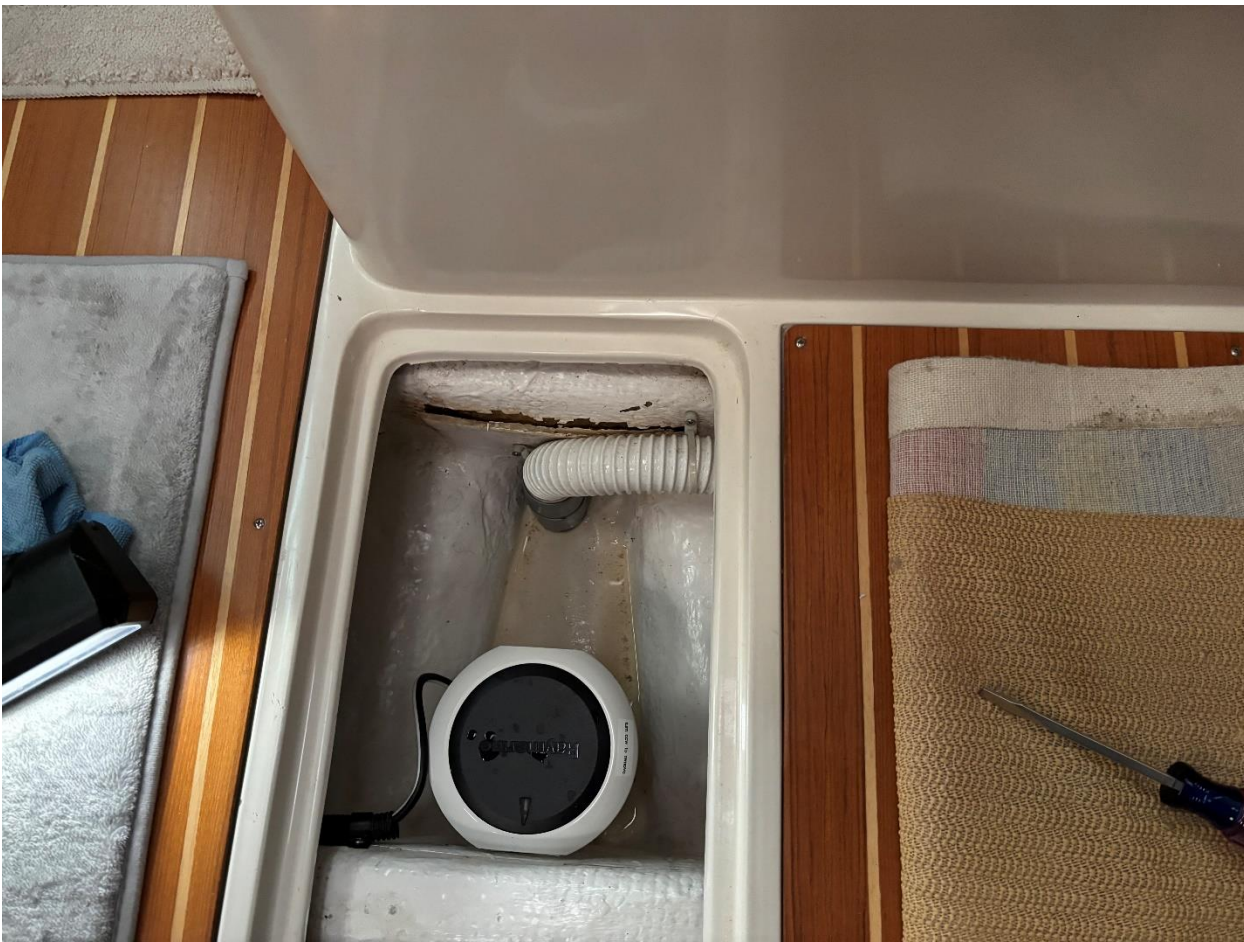
Likely cause is water penetrating at the screw holes holding the manual bilge pump in place.

Boat was put on the hard in September, a recent cold spell had an extended hard freeze. Upon a recent visit to the boat during a warm spell the damaged was discovered.

For reference all photos have the aft of the boat at the top. This stringer is the aft most stringer as seen from the salon sole opening. Directly aft of the stringer is the liner forming the seat in front the galley sink.

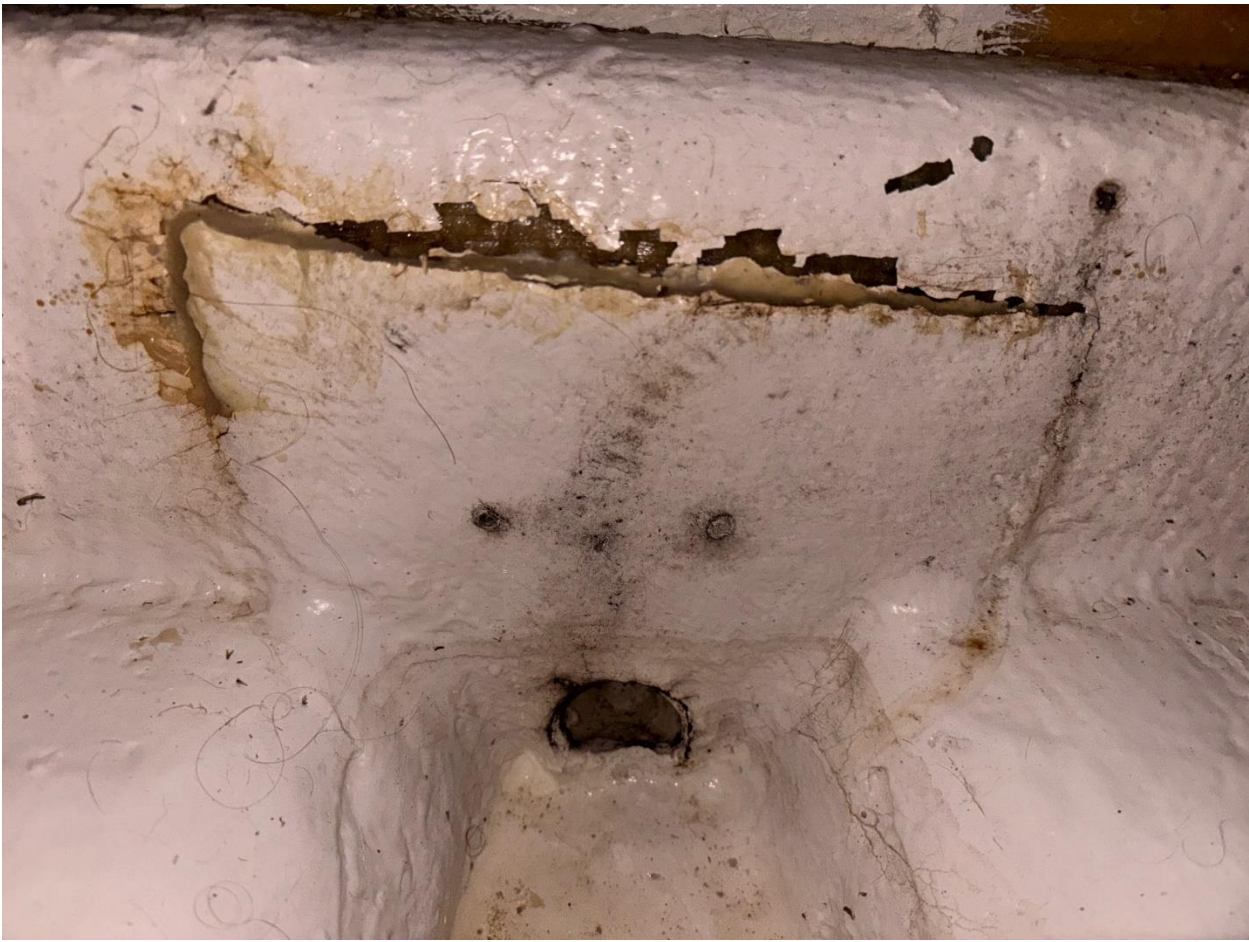
The next picture shows evidence of epoxy repair it did 7 years ago when I noticed some minor delamination at the location.

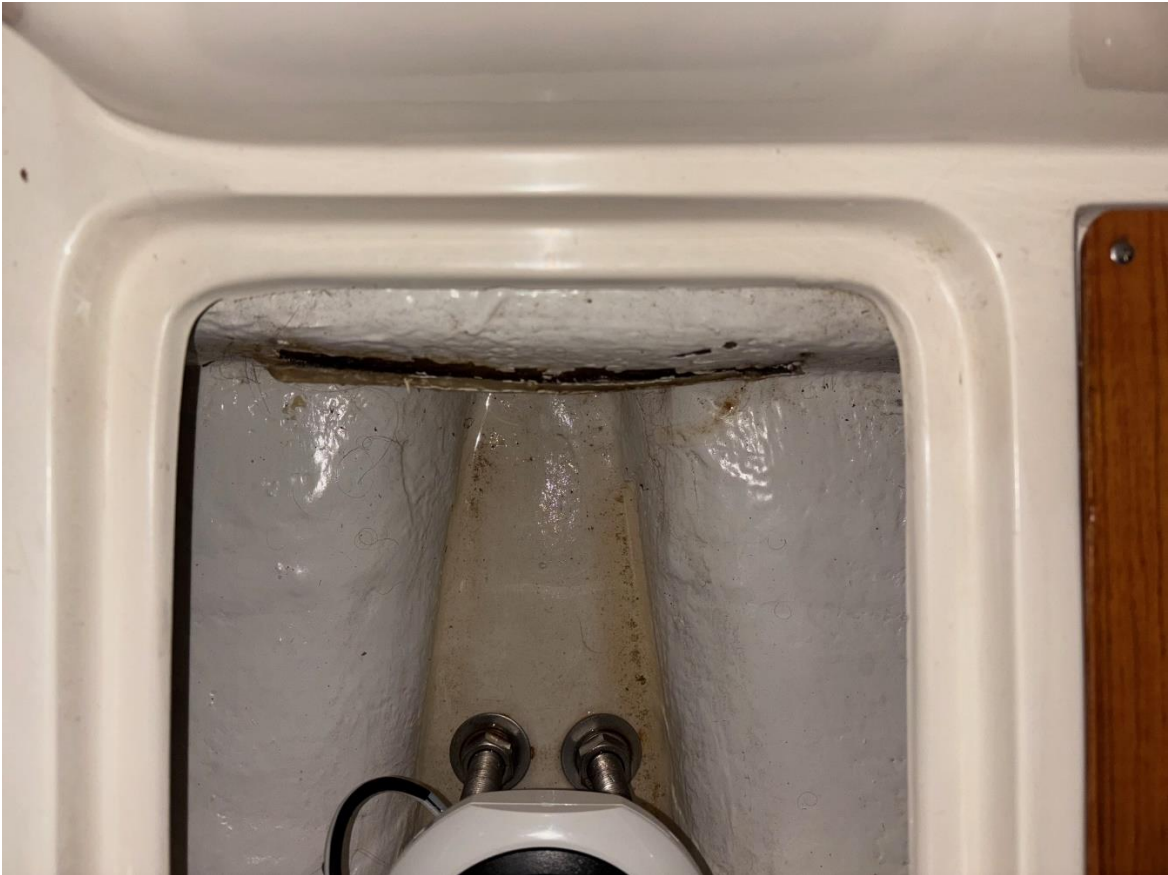
The next picture is more directly overhead and captures the extent of the bulge where the glass is being forced away from the stringer. Bilge hose is no longer attached to the damaged area.

Using a screw driver handle to tap along the stringer, both top and bottom, all sounds solid with the exception of the delaminated area and the space left and right of the delaminating "flap".

- Does anyone know the lamination schedule of the stringers?
- Is the base stringer marine plywood or solid wood? How thick is the wood?
- Would cutting the damaged area away, digging out the wet wood and replacing with epoxy, then layering new glass matting over the damaged area be a sufficient repair?
- Should a wood or starboard substitute be epoxied in place rather than the fill of just epoxy?
