Mast Step Replacement – 1983 Mark I Catalina 36
Jason Vandergaag (“Nimue”)

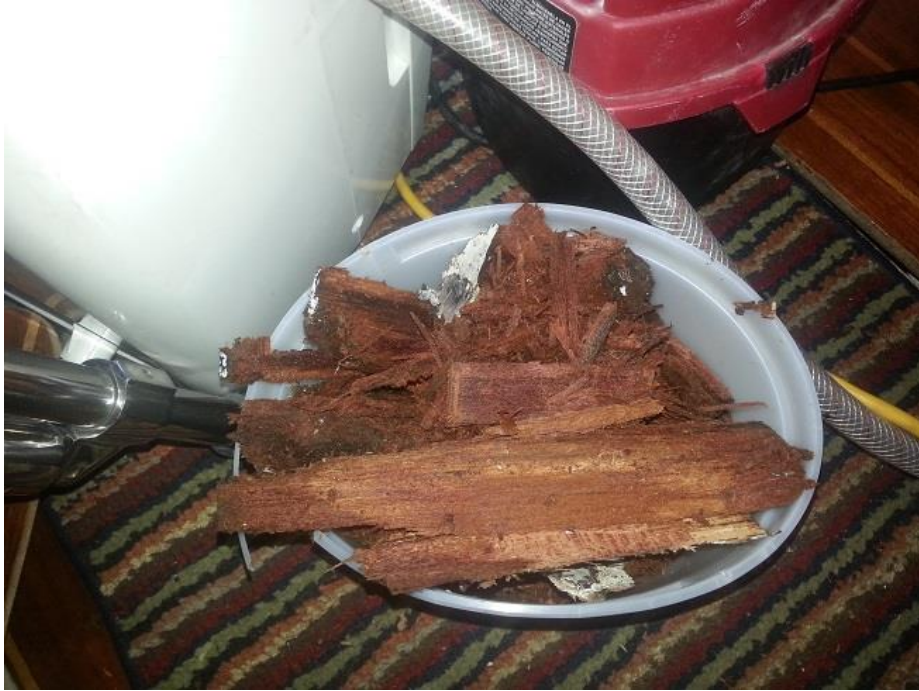
I was expecting to find a stack of rotten plywood, based on a C30 I looked at a while ago. Instead, I found a block of totally rotten and wet red cedar. It mostly came out like that mulch stuff that people put in their gardens.

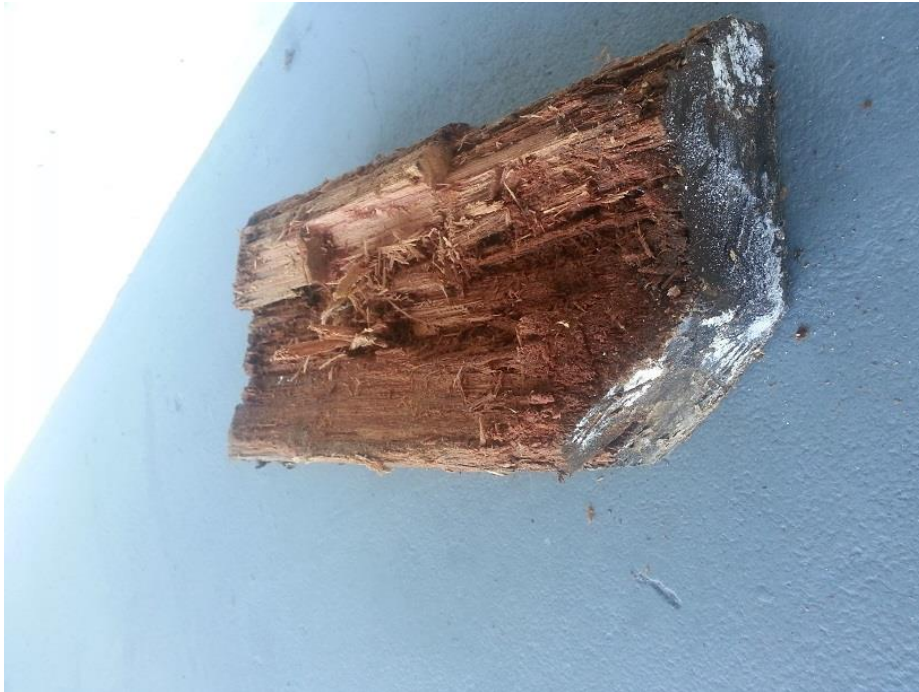
I filled two ice cream buckets with mulch and splinters, and then was able to just grab the block and pull it out. No glue, no fuss. All the wood was soaking wet.

What I believe precipitated this is that the drain paths out the bottom of the mast are TINY and were totally plugged with dirt, lint, dust, etc. Water would stand inside the step, and the step was held in place with four 5/16" lag screws through the floor and into the cedar block, so water would wick down these screws and enter the wood easily that way. Of course, the cedar block was not treated or sealed in any way so it was only a matter of time.

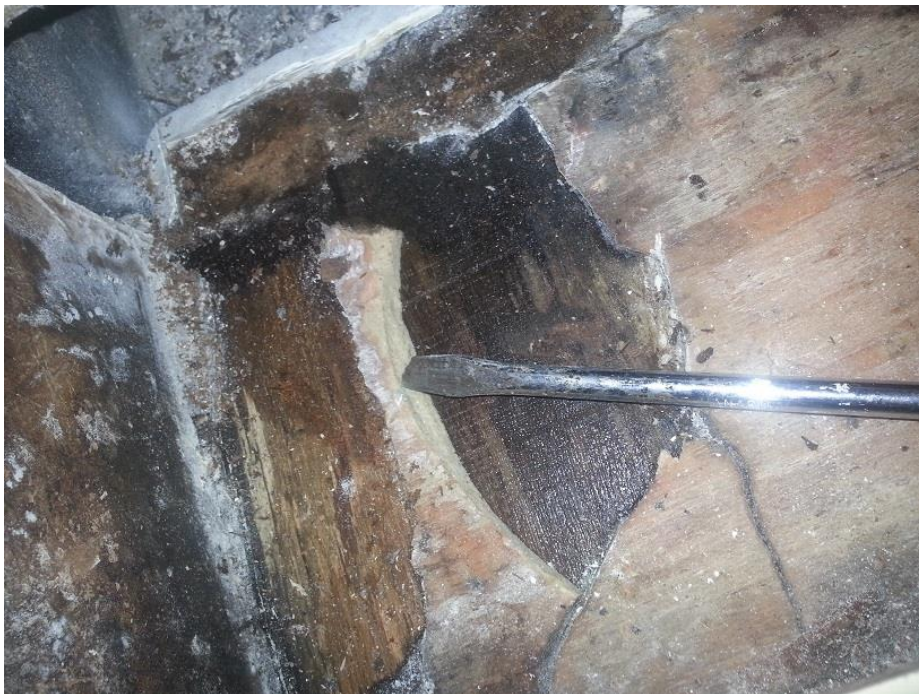
Then I made the mistake of probing a bit at the lower timbers - and the 'fiberglass' layer on top popped right off. It appears to be what my boatbuilder friend calls "bear shit" - leftover polyester resin thickened with leftover sawdust, and often used in boat building to fill gaps. This chipped right off and the timber underneath were exposed.

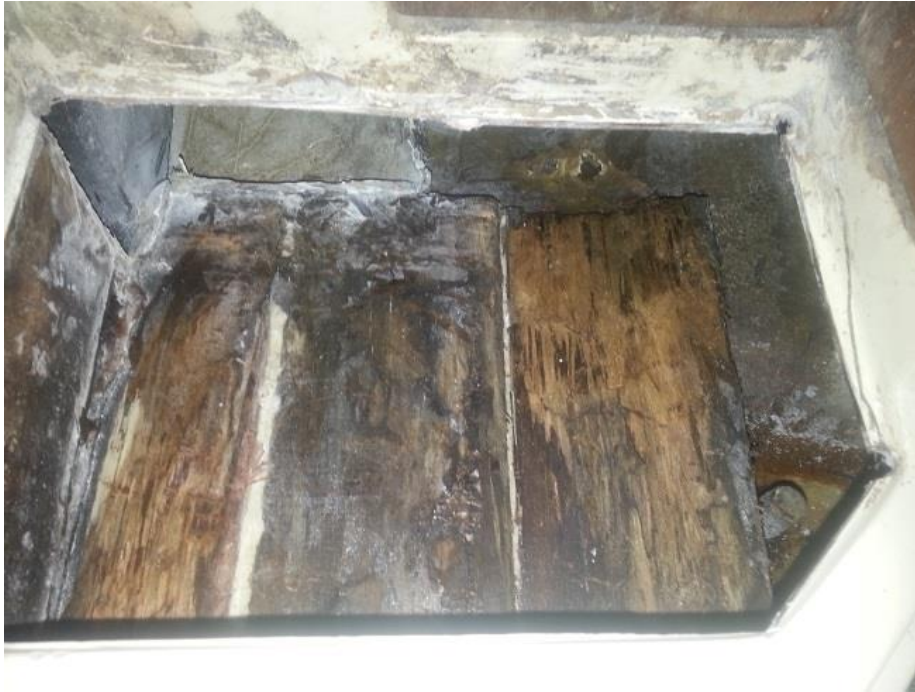
What I found is three very thick hardwood beams spanning the keel box and bedded in polyester goop. These were wet also, I would assume they wick water up from the bilge if there is more than 1/2" of water in the bilge. However they did not seem rotten except for one soft spot in one corner which I removed. I called a couple guys who would

know better and let them talk me out of removing these timbers, so I 'glassed over them after removing any soft spots. The platform formed by these timbers is 12" wide and 11" long.

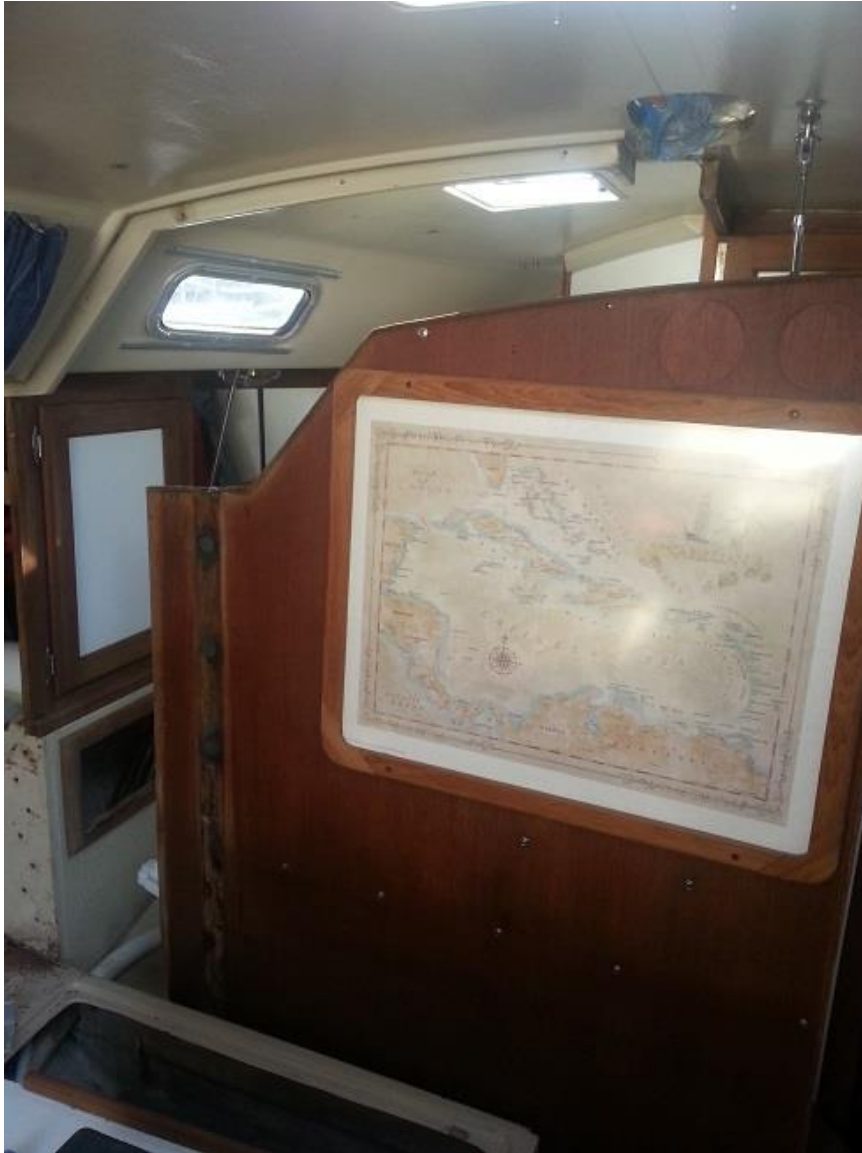
The bulkhead is formed in two major pieces - the bulkhead itself, and the corner post which goes around the mast and forms the corner of the head enclosure. The corner post is made from two solid wood planks glued together.

The bulkhead is held in place by the chainplate bolts on the side, six 3/8 bolts (really machine screws) along the bottom into the liner, and 4 #10 self tapping screws along the top. It fits into a dado groove in the corner post at the right hand side.

The corner post is just held in place with 6 self tapping screws, 3 top and 3 bottom. In my boat this was all rubbing and flexing everywhere, making horrible groaning noises, and not doing any structural work.

Once the corner post was out, the bulkhead slid to the right and popped right out of its groove. No evidence of any adhesives was found anywhere.

After all the mating surfaces were cleaned and sanded, I slid the bulkhead back into place. I used a hydraulic jack to push the bulkhead up and to the left, mating the outer and upper edges as tightly as possible, and drilled 3/8" holes to through bolt this connection. Then I pulled it back out and applied West epoxy to all the mating surfaces. I think if I was doing it again I would use 3M 5200 as it fills gaps better, but I already had the epoxy.

I replaced the six 3/8" bolts in the lower edge of the bulkhead, and added an aluminum flat bar backing plate to spread the pressure out. In all cases, I used bolts with long un-threaded shanks so that they wouldn't saw on the wood bulkhead, and I used hex-head bolts so that I could actually torque them up a bit. The factory used flat-head machine screws, fully threaded, and acorn nuts which could not be tightened enough.

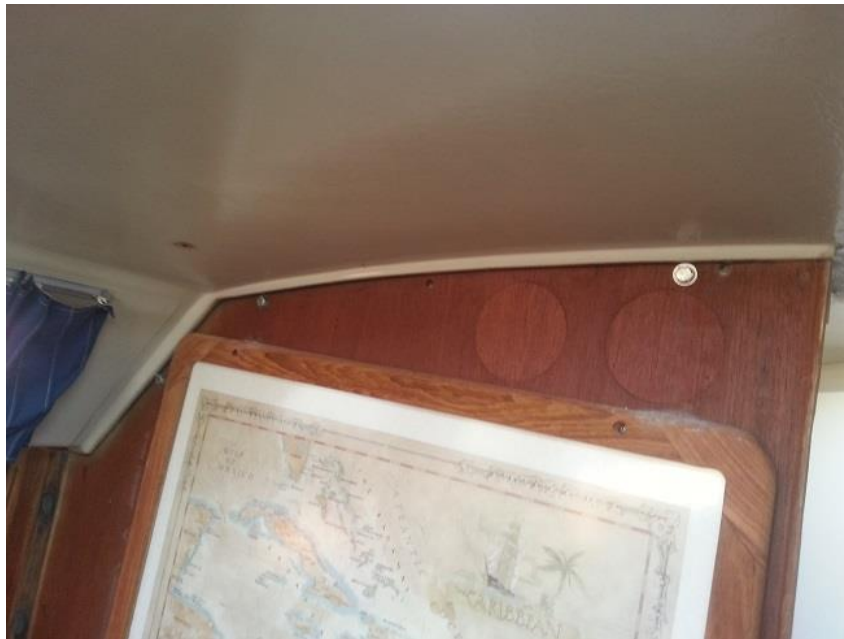
If you go back up to the picture I attached earlier in the first post of this thread, you can see the gap at the bottom of the corner post. This gap is GONE - the whole assembly fits tight in place now.

The corner post got roughly the same treatment. I was only able to add one through bolt at the top for geometric reasons, and the lower bolts had to be carriage bolts to clear the mast. However, I epoxied the top and bottom faces, and epoxied the whole groove that mates to the bulkhead. I think this will make it much stronger. The one self-tapping screw that I couldn't replace with a through bolt got instead a 1/4" square-drive self tapper so it is much stronger than before.
