Transom repair SILER

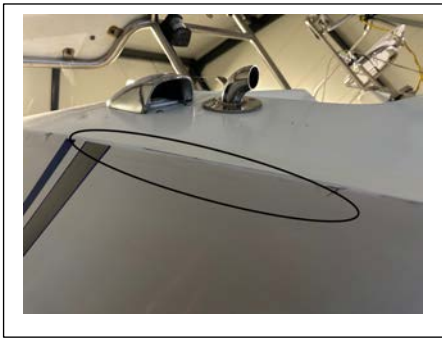
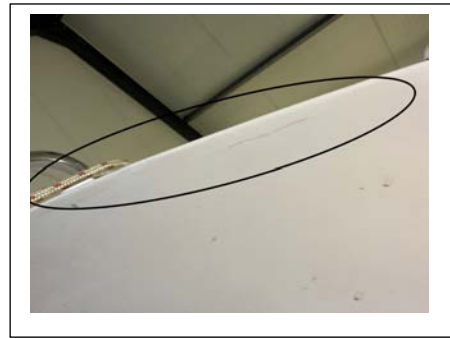
We noted during the summer thin hair-cracks in the gelcoat on various spots all around the transom.

Having in mind that hair-cracks could result later in issues with osmoses we wanted to check what a reason could be.

First, we started to grind-off all the gelcoat of the transom.

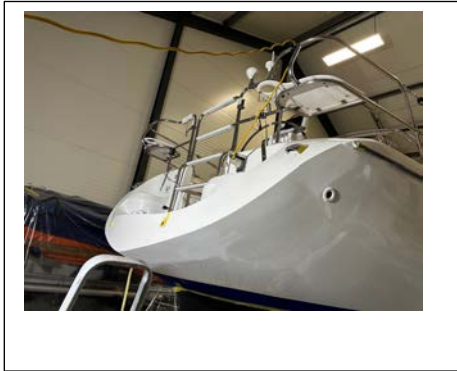
The result after the repairs / polishing, pending to apply the hull-stripping and ships name.

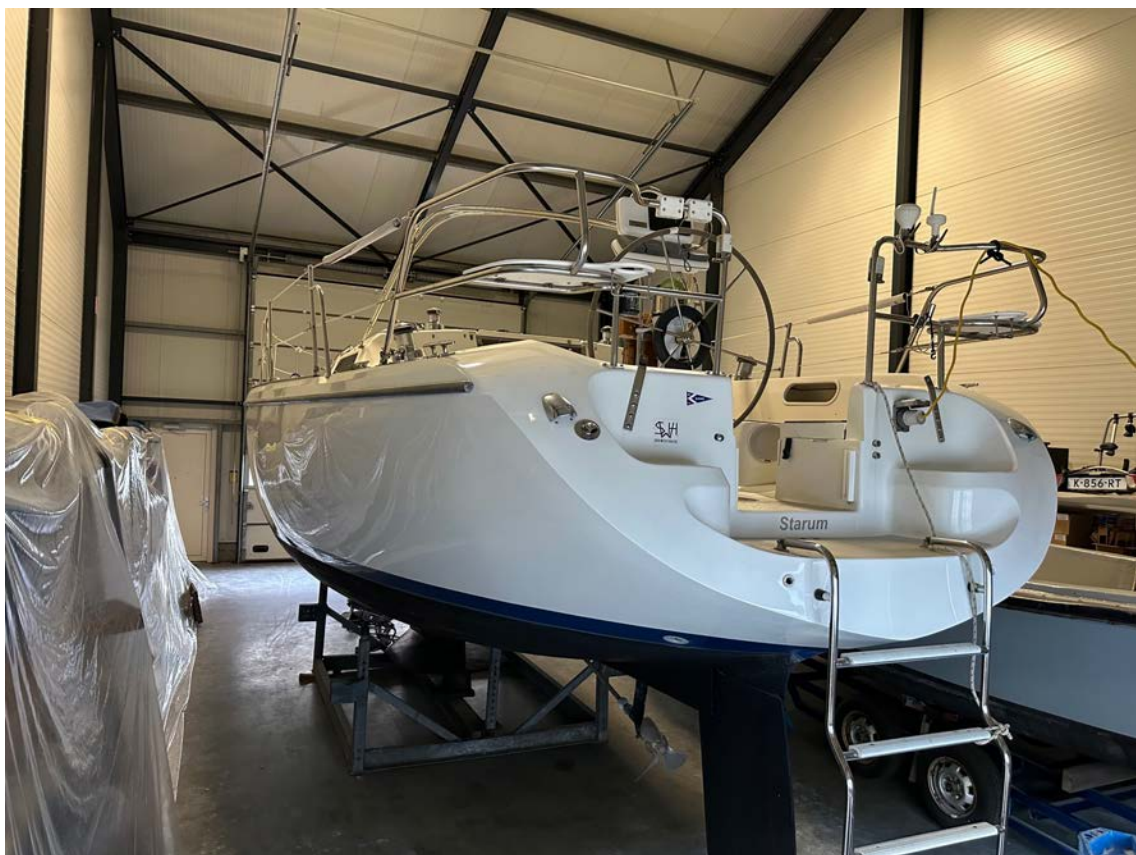
A real beauty again!! Like new.

With the new gelcoat matching the polished hull, we started to apply the layers of new gelcoat to the repaired area.
