# Maxwell Windlass Model VW-800 Catalina 36 MK-II #2164 - Windlass Maintenance

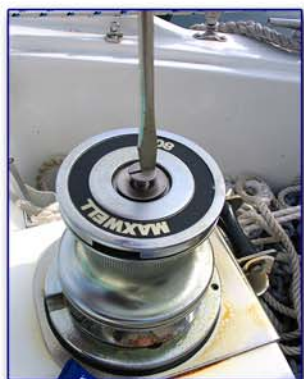
Remove Rubber Cap, screw and washer

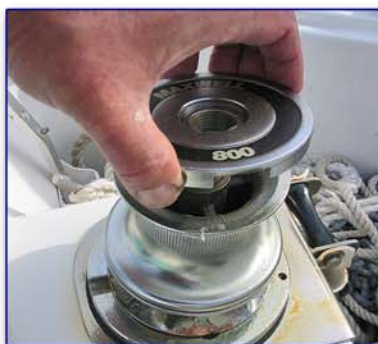
Unscrew (counterclockwise) top

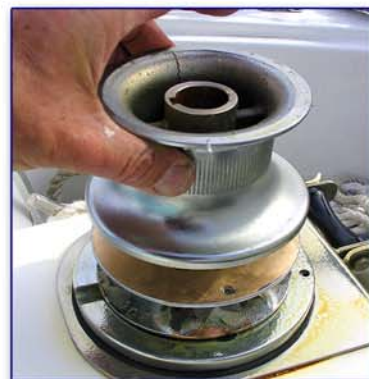
Lift drum vertically on keyed shaft

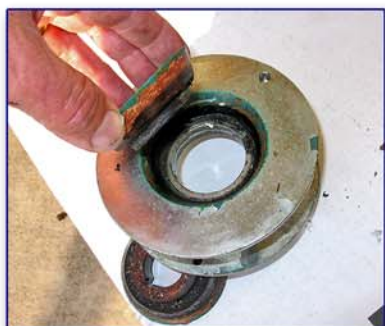
Remove clutch assembly off shaft.  
Brass cones may need to be pushed out by screwdriver if stuck (mine were).  
Note heavy corrosion.

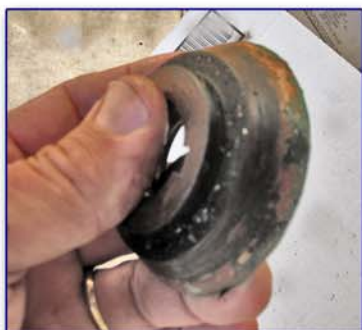
Heavy corrosion on clutch cones

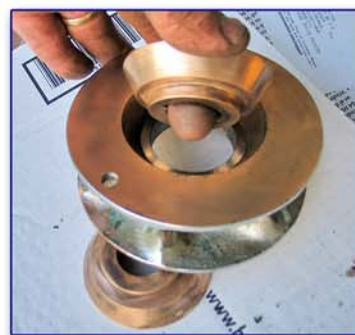
Clutch assembly after cleaning with solvent & wire brush. I applied "Lewmar Greargrease" (or see Maxwell specs) to clutch surfaces.

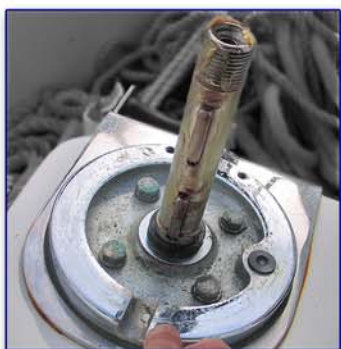
Windlass base prior to re-assembly  
- grease shaft & threads.

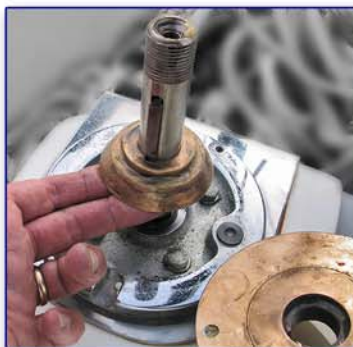
Re-assemble 3 pc brass clutch on shaft over 2 keys

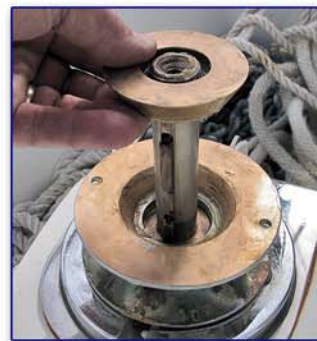
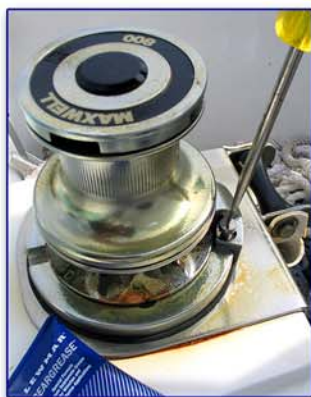
Slide drum back over shaft, screw on the windlass top plate, tighten screw/washer, replace rubber cap.  
Replace two screws holding the "chain-deflector" device (?) (left), spray with corrosion inhibitor as per Maxwell suggestion.  
(Residue on left is this inhibitor)
