Mast Step Replacement – 1983 Mark I Catalina 36
Jason Vandergaag (“Nimue”)

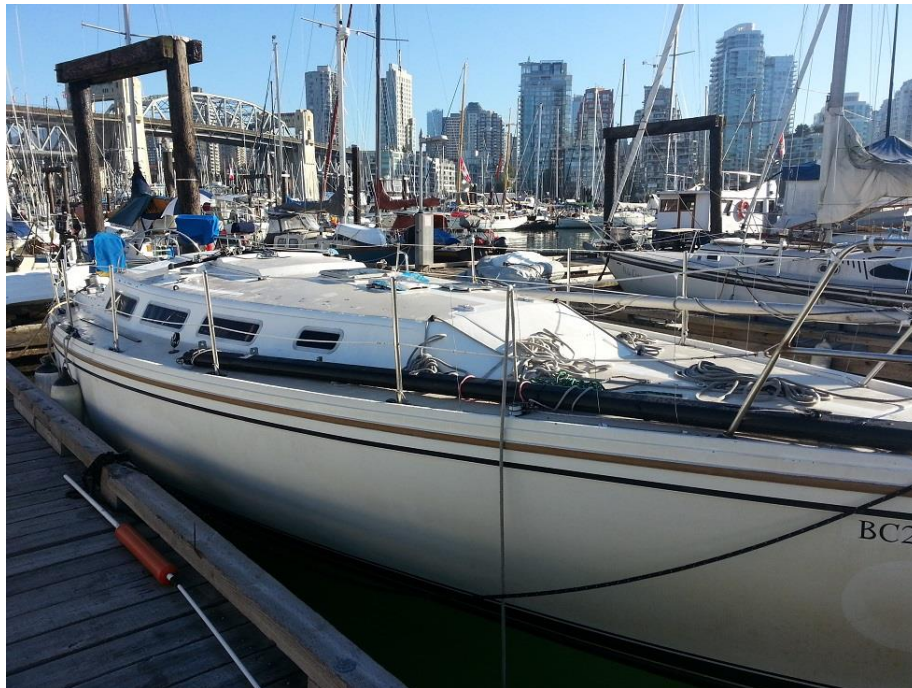
I started by pulling the rig, which in the PNW is harder to arrange than you might think. But we got it out with the help of the Granville Island Boat Yard which I highly recommend if you are in Vancouver.

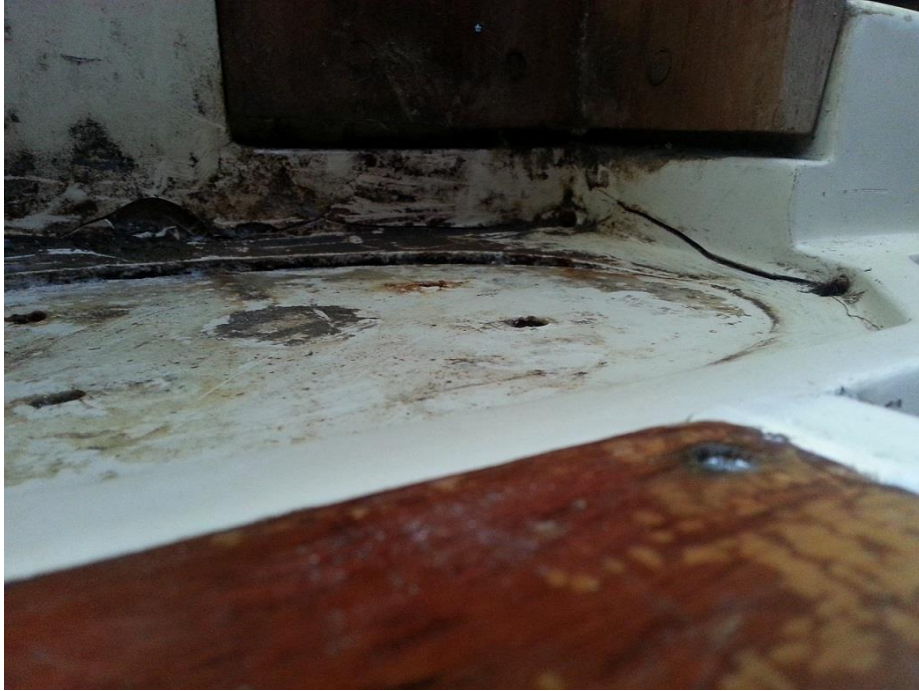
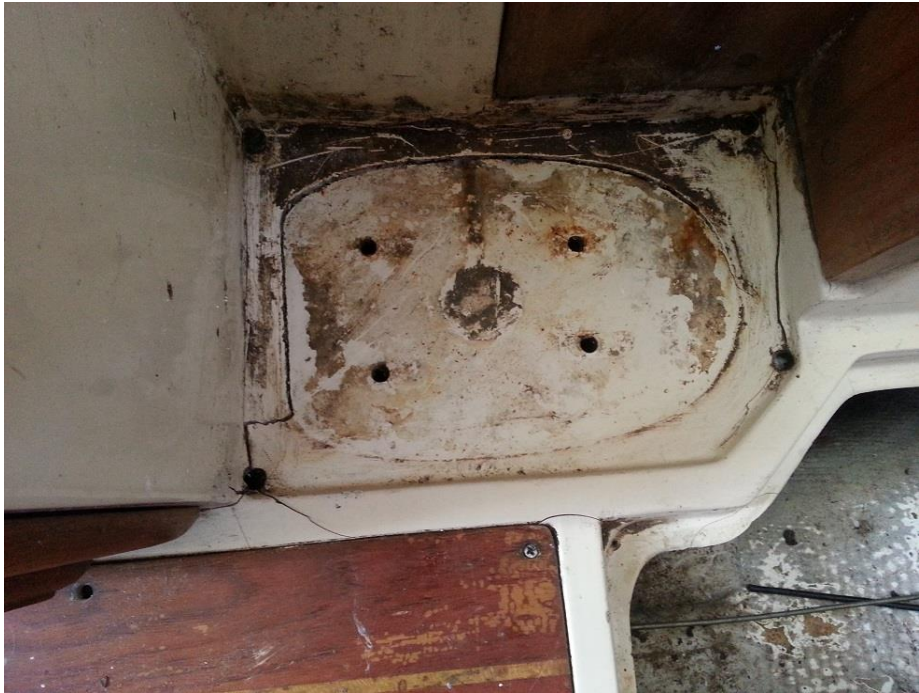
Then I cut out the floor pan around the mast step. This was easy with an oscillating multi tool like a knockoff Fein Multimaster. Great tool by the way.

I was expecting to find a stack of rotten plywood, based on a C30 I looked at a while ago. Instead, I found a block of totally rotten and wet red cedar. It mostly came out like that mulch stuff that people put in their gardens.

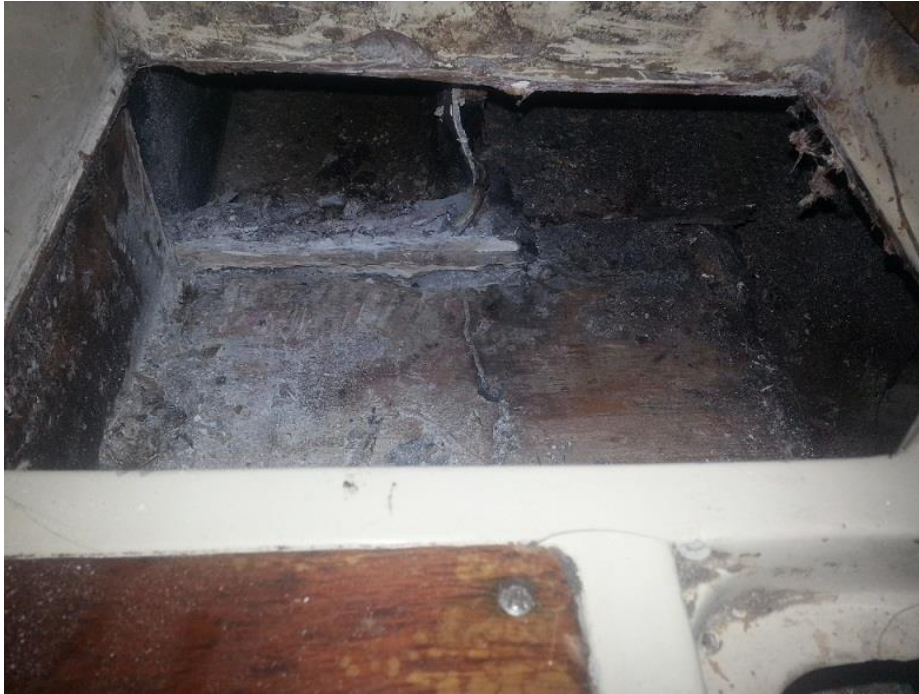
Anyhow, the cedar block was sitting on top of what looked like a fiberglass covered chunk of wood spanning the keel sump, and that looked OK so I was hopeful the demolition stage was over already.
