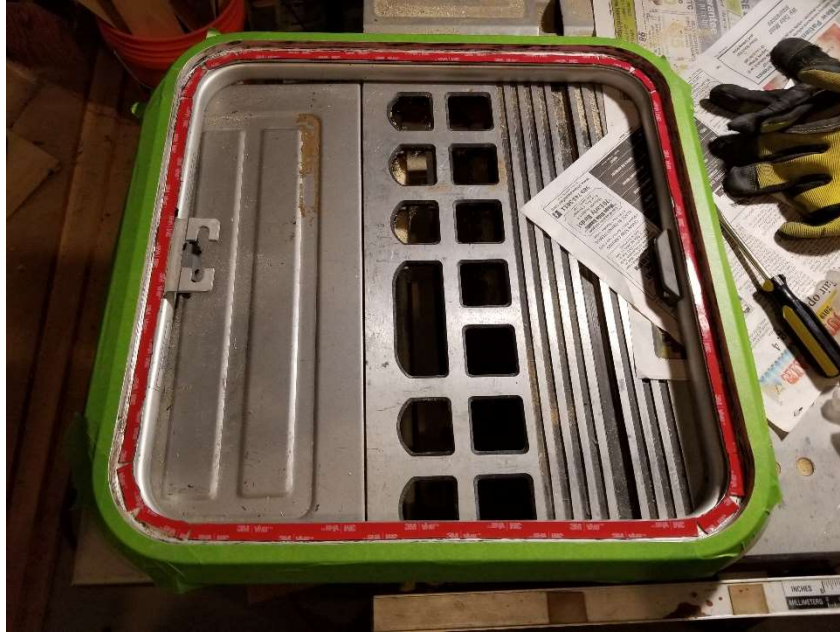
The old lens is out, the VHB tape is down in the frame (red backing), and the green masking tape is one the frame.

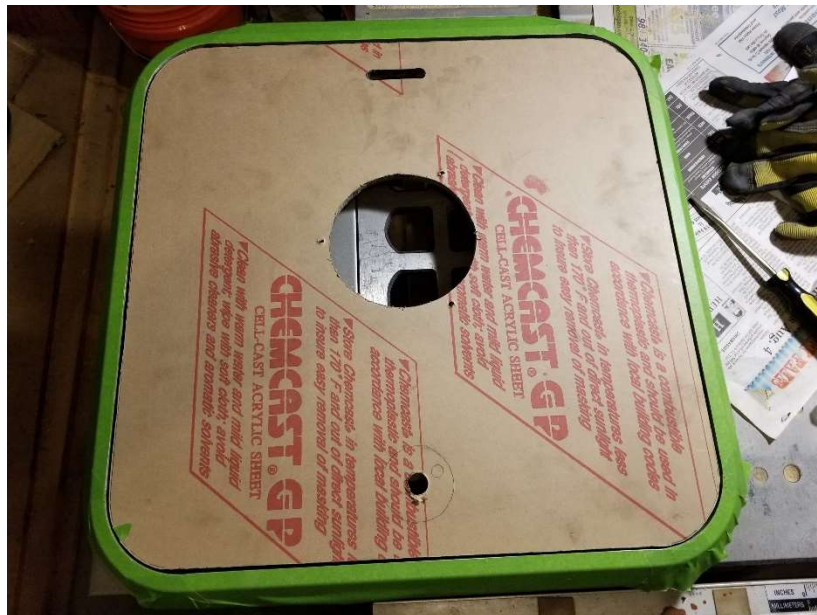
The new lens is in place and the first pass of Dowsil 795 is in the groove.

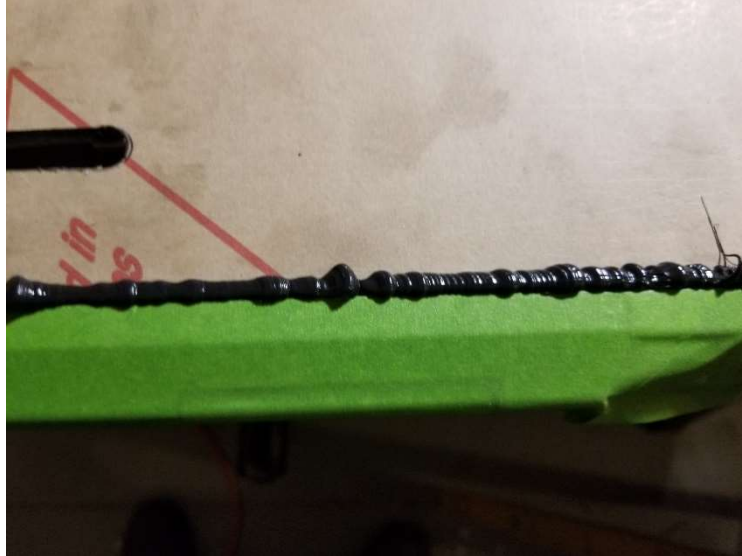
Close-up of the first bead of sealant before running my finger around the joint to smooth it.

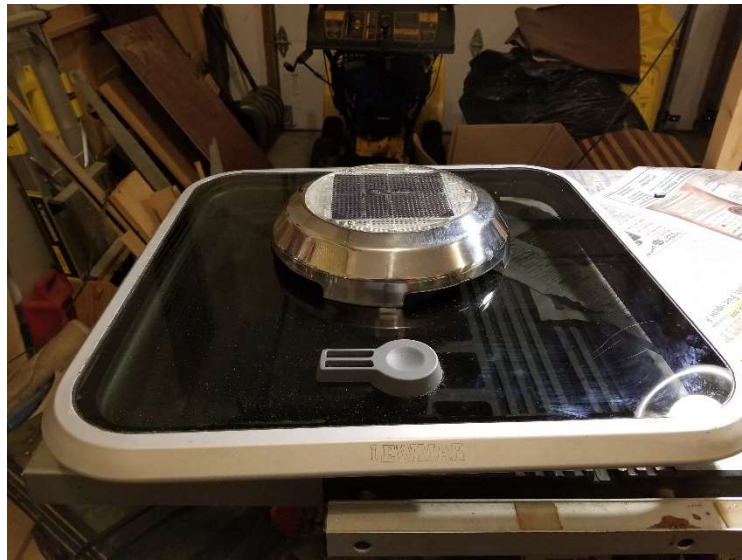
The finished hatch.
